BUILDING SURVEY REPORT

SURVEY DATE 19 Dec 2017

The format of this MiBuilding Survey Report is consistent with the guidance note requirements for a Survey Level 3 as defined by RICS Surveys of Residential Property 3rd edition May 2016

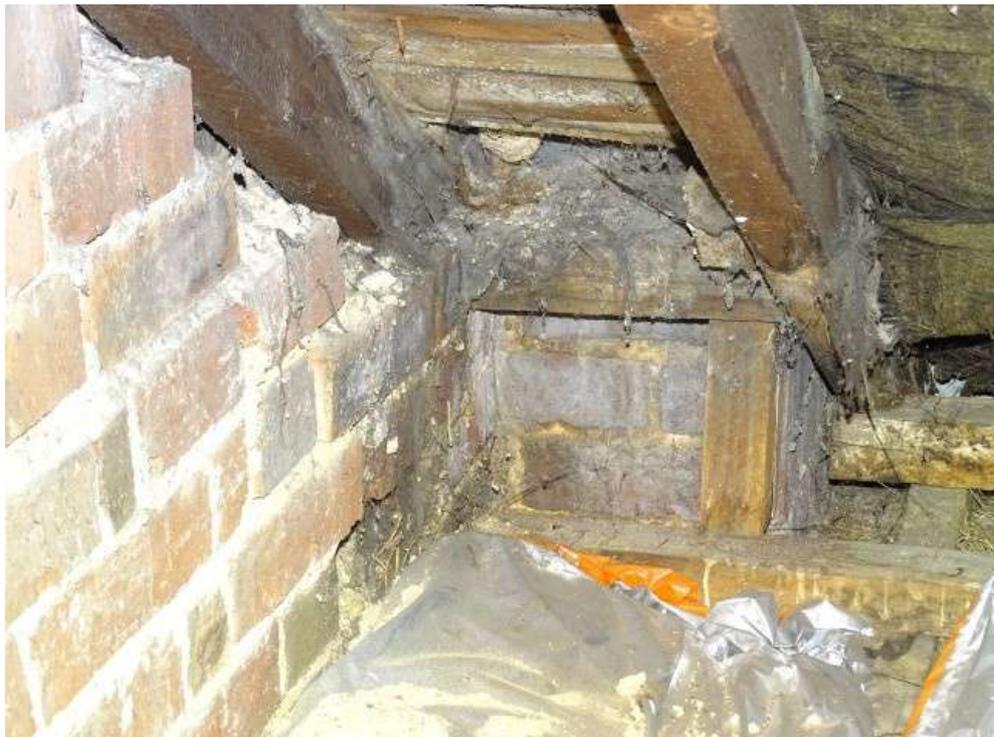
Chimney stack from small front bedroom showing dropped sarking felt

Nature of inspection and Limitations	<p>The chimney was examined from ground level with the aid of binoculars for possible defects including undue movement, distortion, chemical or weather related damage, brickwork, render and pointing damage and other evidence of failure.</p> <p>Due to limited viewing angles it is not possible to see all faces of the chimney stack from ground level, and it is assumed that the condition of those faces not visible is similar to that of the visible faces.</p>		
Condition	<p>All flashing's should be replaced in lead ,There is a crack between the two chimneys between the properties this should be sealed to prevent water getting down the back. brickwork and pointing seen were in a fair condition.</p>		
Action Required	<p>The pots to the main stack do not have a rain cowl correctly fitted to allow flue gases to escape but prevent vertical rain entering the flue line both flues should be ventilated at the base of the flues to clear damp in the flue .</p> <p>Bedroom 3 fireplace has been capped over. The tiled flashing has cracked and is allowing water to penetrate. The bottom rows of tiles will need to be removed and the flashing replaced in lead and sarking felt checked and replaced where necessary and the back gutter</p>

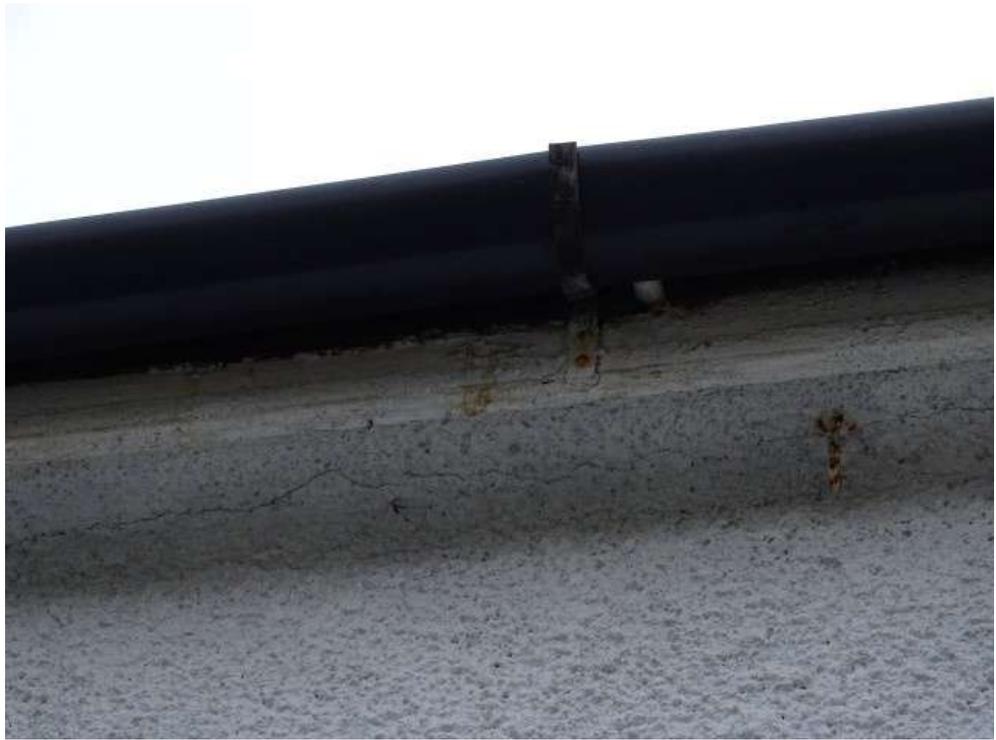
Condition	<p>The gutters are currently in fair condition and alignment. There were no significant leaks noted but all gutters require examining periodically and clearing of moss, leaves and silt which will inevitably accumulate.</p> <p>All gulleys were clear at the time of the survey with no evidence of any flooding or other drainage problems. However all gulleys require regular clearing of any debris that will accumulate over relatively short periods of time.</p> <p>The soil stack and associated plumbing is in a fair condition with no leakages noted.</p>		
Action Required	<p>Gutters and downpipes should be cleaned and inspected regularly to ensure that they are free from blockages and leaks. The rear gutters to the main house are fitted with old metal brackets these should be replaced. The gutters to the rear right hand side look very wavy and should be realigned with additional brackets and cleaned out.</p>

Rear gutter to main house

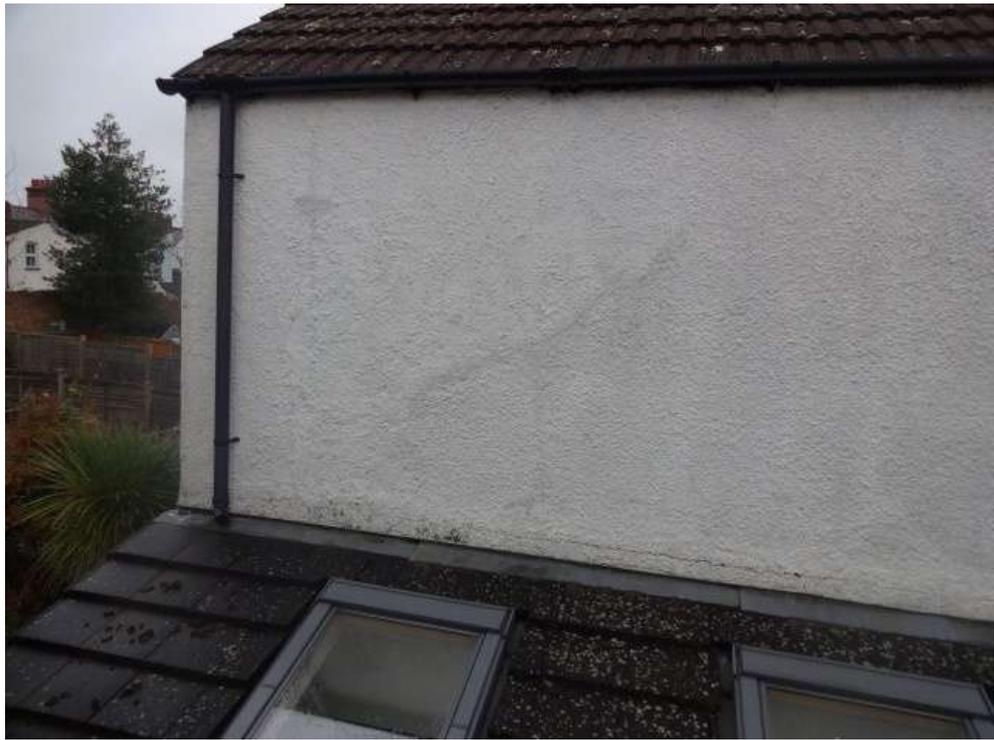
<p>General</p>	<p>The most serious issues present at the time of the survey is the dampness and cracking within the external side walls. There are a number of medium level issues that require attention together with some minor observations made in the following report sections.</p> <p>It should be noted that in any property of this age there will be general unevenness of the surfaces and structures of walls, floors, ceilings, doors, windows and other elements. These have occurred due to settlement of the structure and general usage over an extended period. It is not possible to highlight each individual example of such distortions and only those felt to be of an unusual nature have been highlighted.</p>
<p>Main Issues</p>	<p>-Issue 1 Dampness was found in the rear and right hand gable wall of the kitchen. In the dining room chimney breast at high level. To the covered alley way at low level up to the sitting room chimney breast and in the sitting room from the bay window to the hall.</p> <p>- Issue 2 The render is cracked in the side wall of the kitchen dining area and has been repaired but is cracking again internally it is lined with plasterboard so is not seen inside. The side wall of bedroom 4 is cracked in the render and allowing water to penetrate the wall</p>

Cracked render to bedroom 4

<p>Action Required</p>	<p>The rear gable wall to the right hand side needs repointing. This complete wall has been covered with bitumen and paint and rendered over in area's to prevent rain penetration previously as the kitchen is wet above the worktop areas this will need evaluating by a specialist and to see if there is a guarantee on the damp proofing that was done as the whole kitchen may need to be taken out. The crack in the render may need to be reinforced by the installation of Heli fix style reinforcing product to the side wall and above bedroom one window. This you will need to get a specialist report on. Repoint small area to side of bedroom 3 brickwork.</p>
<p>Additional Information</p>	<p>I can send you details of specialist company's that will give reports on products for repairing the cracks</p>
	<div data-bbox="416 633 1406 1370" data-label="Image"> </div> <div data-bbox="683 1391 1134 1417" data-label="Caption"> <p>Crack above main bedroom window head</p> </div>

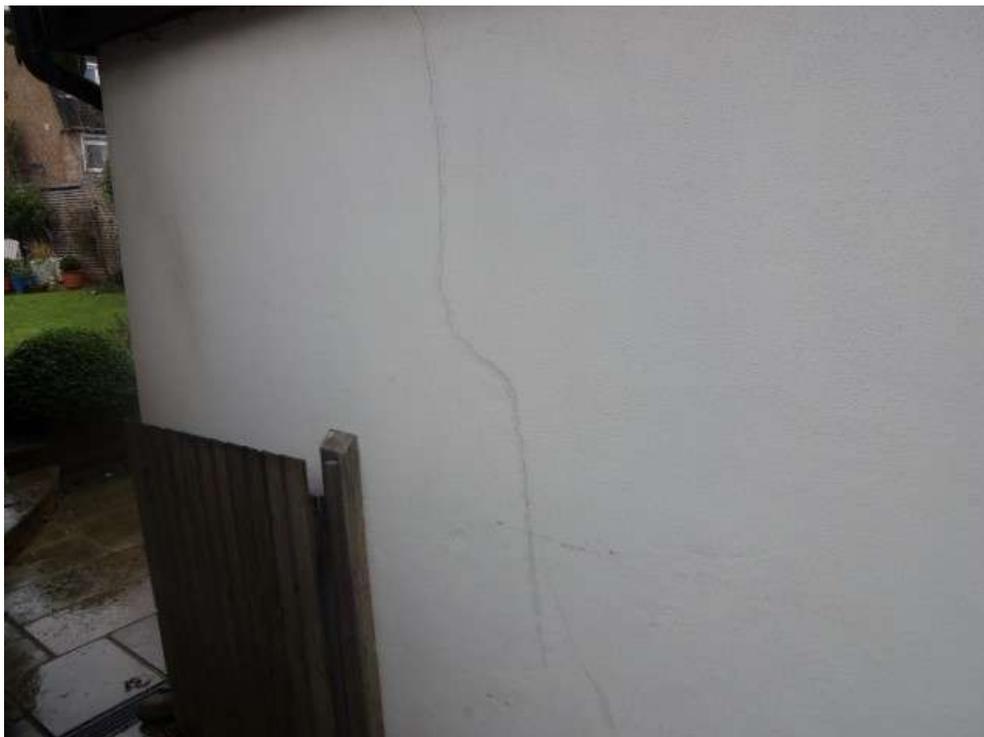
Cracked render to left hand side of kitchen

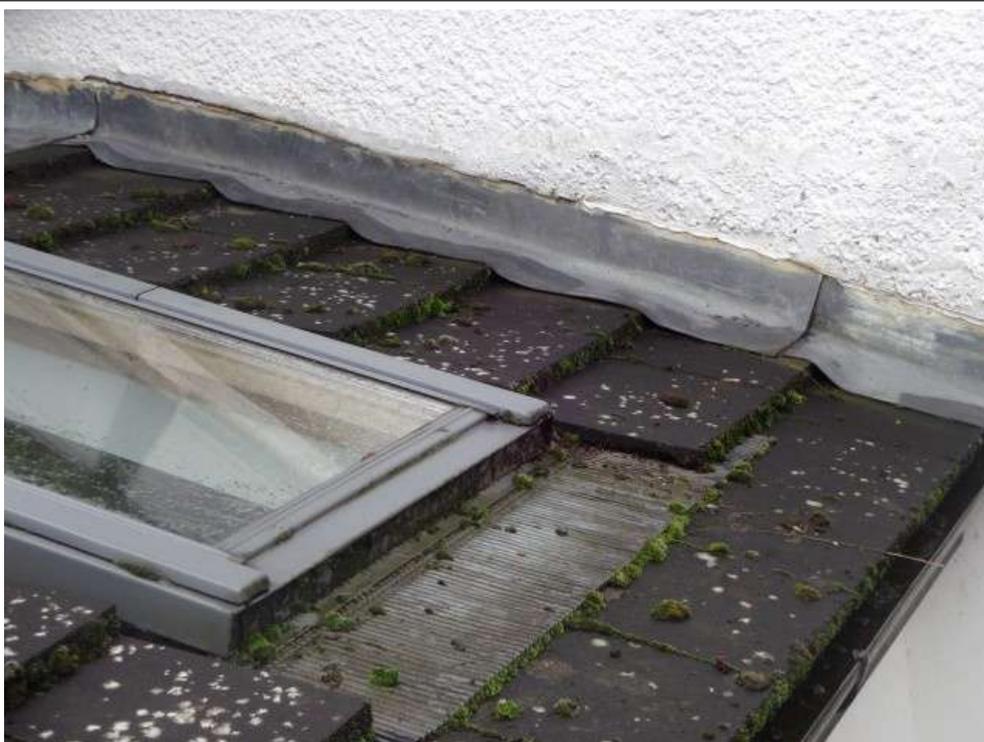
Render cracking above lead flashing onto roof of dining area

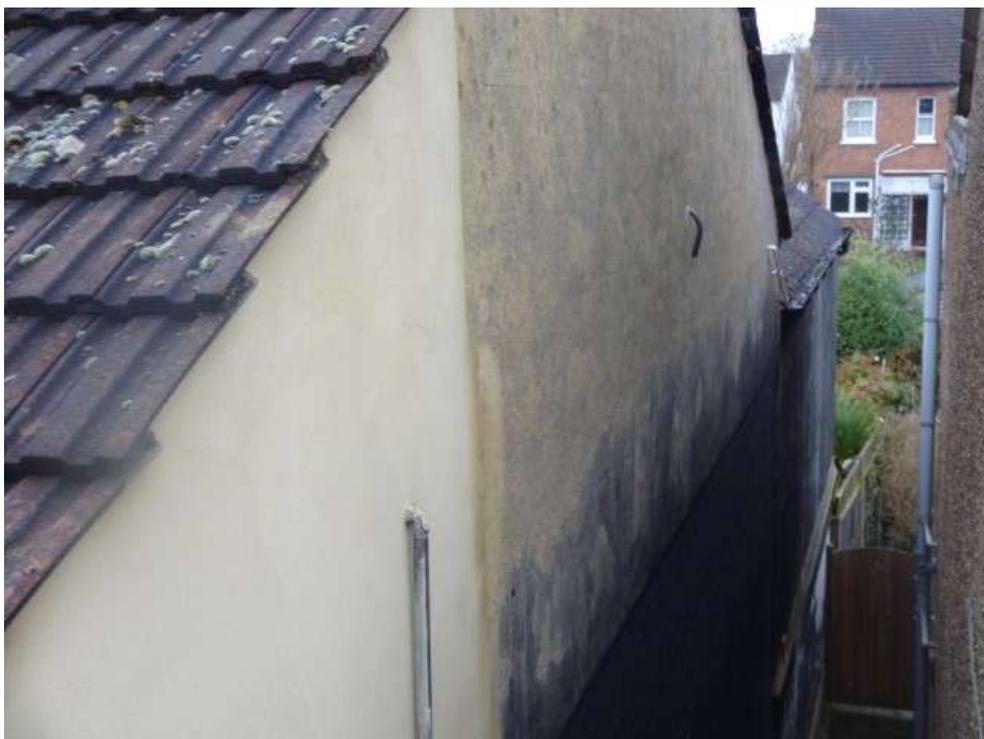
Right hand gable end rendered down to first floor

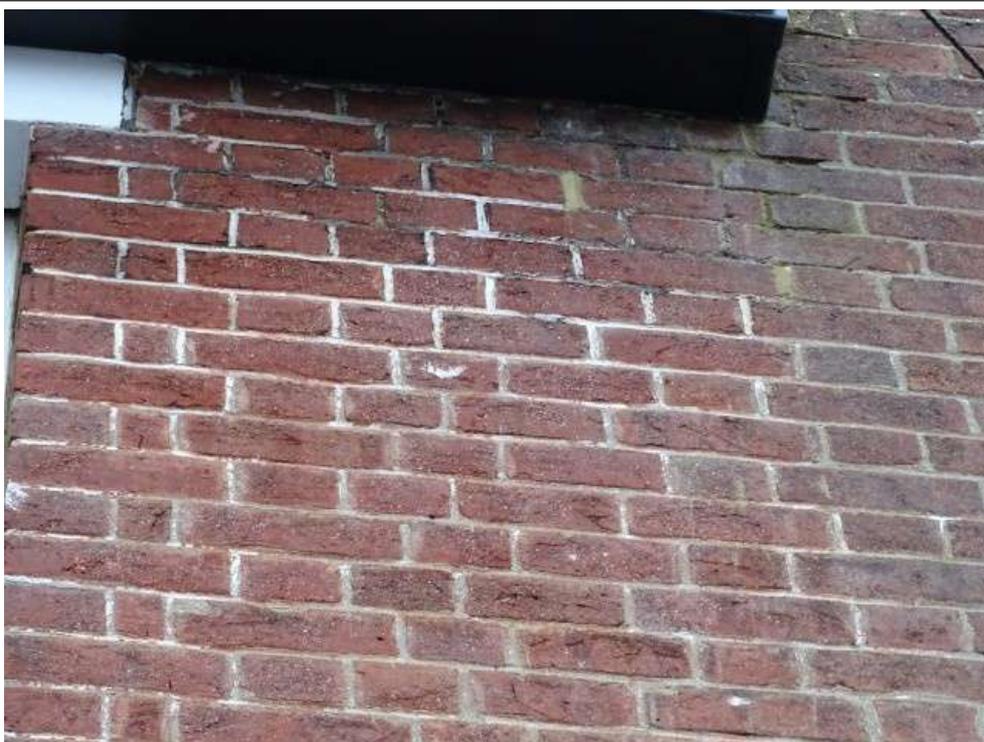
Re-pointing required to right hand side of bedroom 3 window

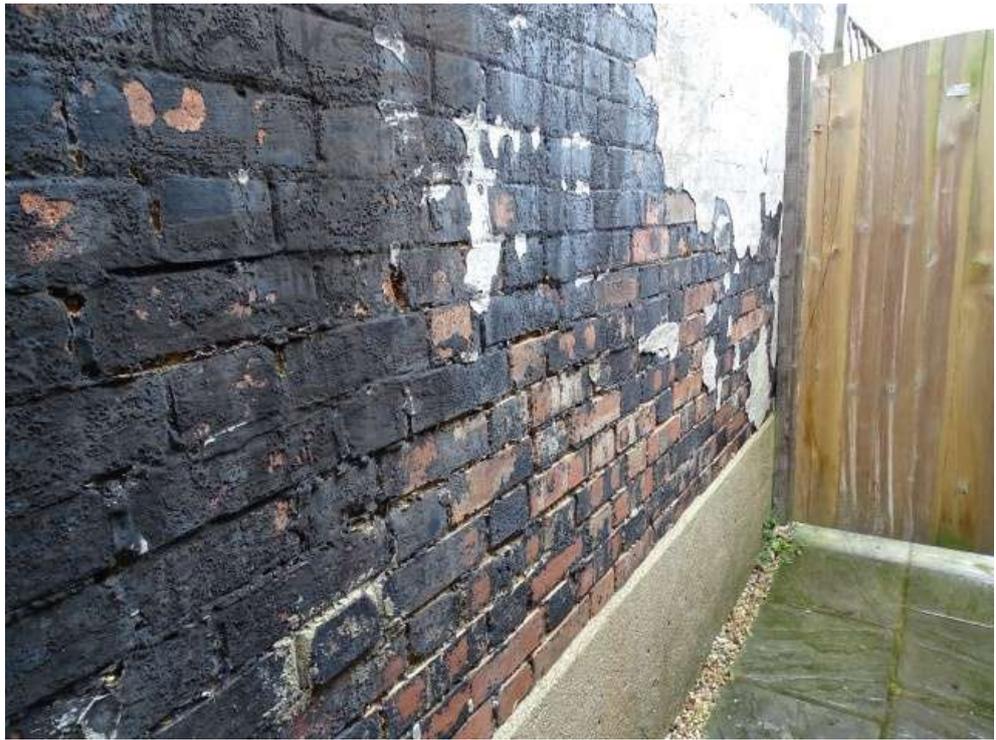
Rear gable wall right hand side rear of kitchen

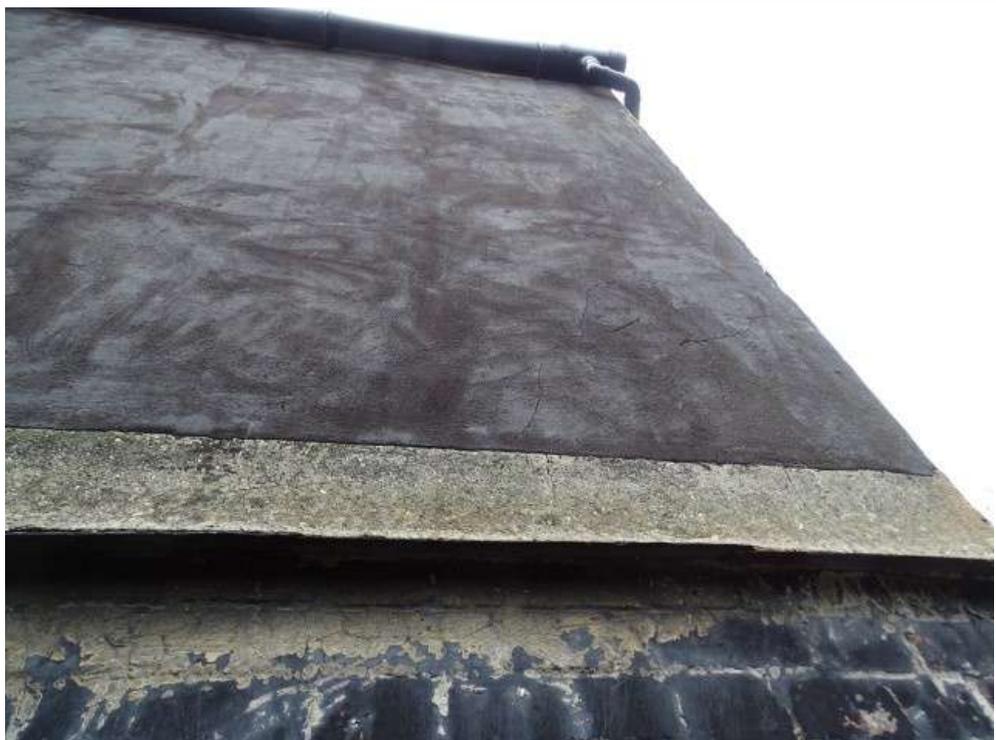
First floor rear gable wall cracks in render

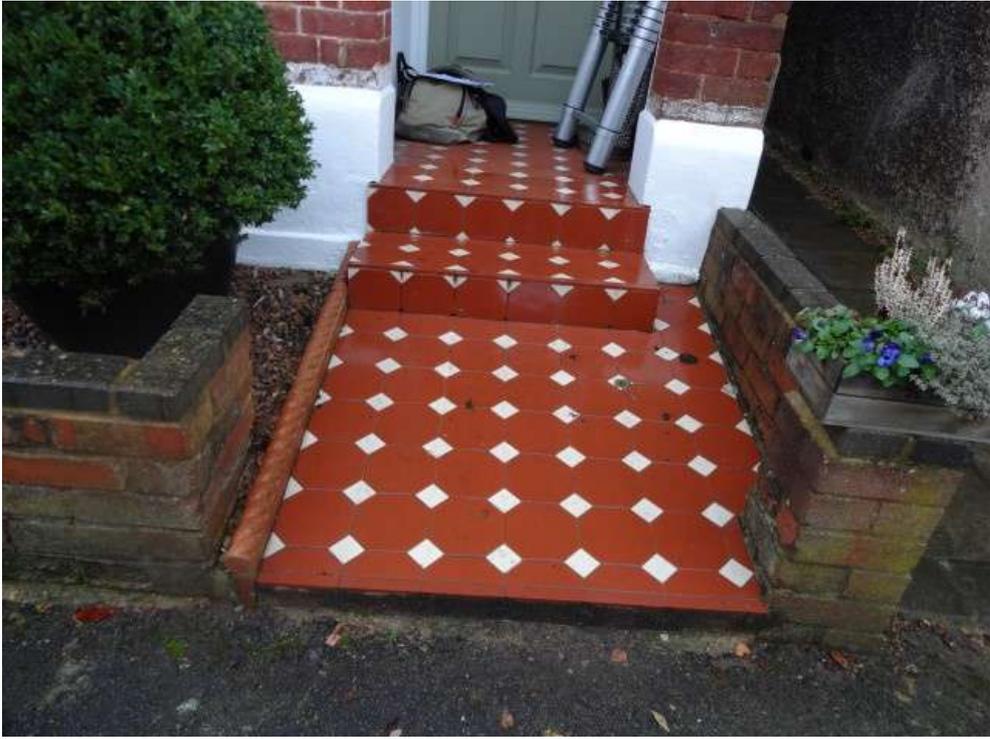
<p>Front step sloping and slippery in the wet</p>

4.7 Conservatories and Porches	Condition rating	1
Construction & Type	<p>The porch to the front is set within the property and is open to the elements. The floor is tiled and runs to the front of the property.</p> <p>There is no conservatory to this property.</p>		
Nature of inspection and Limitations	<p>The porch structure was examined for indications of leaking, bowing, leaning, cracking and failure or damage of the floor, walls and roof and other defects.</p>		
Condition	<p>No significant defects are noted to the structure.</p>		
Action Required	<p>A none slip surface should be fitted to the external sloping tiles.</p>

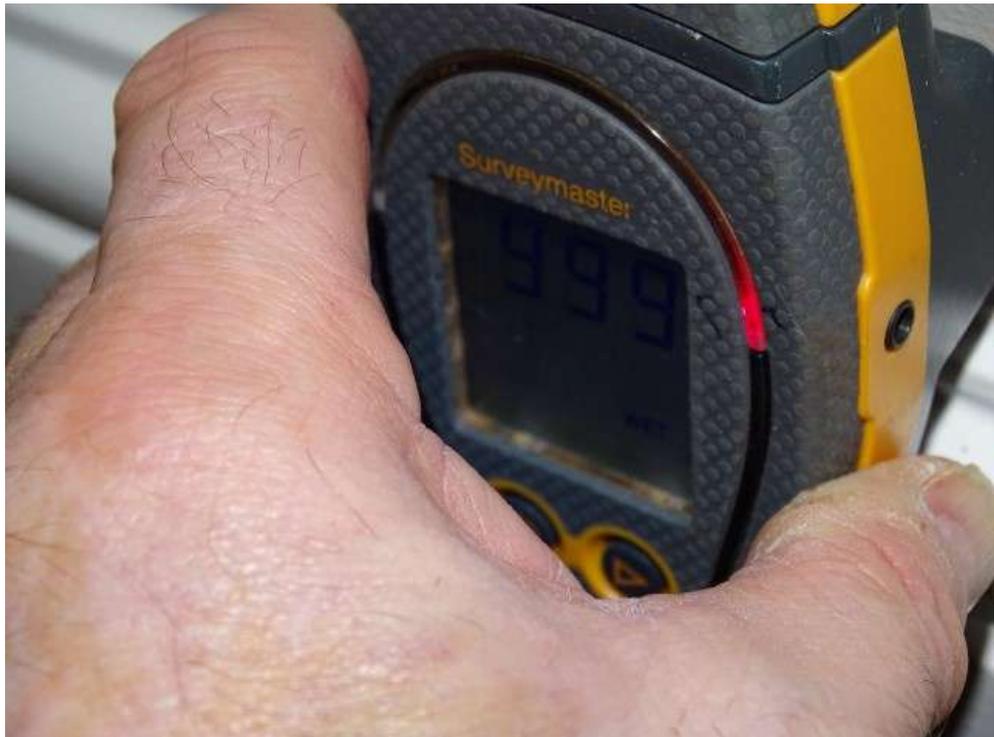
5.3 Walls	Condition rating	3
Construction & Type	<p>The internal walls are of both solid and timber stud construction.</p> <p>The inside faces of some of the external walls have been dry-lined.</p>		
Nature of inspection and Limitations	<p>Internal walls were examined for indications of bowing, leaning, cracking and undue surface failure/damage. Moisture meter readings were taken at regular intervals where access and wall construction/location permitted.</p>		
Condition	<p>All internal walls and ceilings have been maintained and all surfaces are presented in a fair decorative order. Some general unevenness was noted. This is due to normal disturbance of the surface by decorations, minor repairs and fittings having been attached in the past.</p> <p>Dampness was found in the rear and right hand gable wall of the kitchen. In the dining room chimney breast at high level. To the covered alley way at low level up to the sitting room chimney breast.and in the sitting room from the bay window to the hall.</p> <p>Some of the internal walls are dry-lined or of timber stud construction. This means that special fixings will be required where heavy objects are to be hung onto or attached to the walls as the plasterboard facing of the walls is not sufficiently strong to carry heavy weights. It will also be the case that picture hooks and other nailed-in fixings will only have a light hold within the wall facing.</p> <p>No significant defects were noted during my inspection and the internal walls were found to be structurally sound.</p>

Dampness to front wall of sitting room

Action Required	<p>Wall Removal: As part of the legal process, your legal adviser should contact building control at the local council and obtain any records of any notifiable works completed.</p> <p>Normal maintenance is required, including filling and redecorating cracks as necessary.</p> <p>Dampness was found in the rear and right hand gable wall of the kitchen. In the dining room chimney breast at high level. To the covered alley way at low level up to the sitting room chimney breast.and in the sitting room from the bay window to the hall.</p>		
Additional Information	<p>A specialist should be contacted to give a report and quotation for treating the walls.</p>

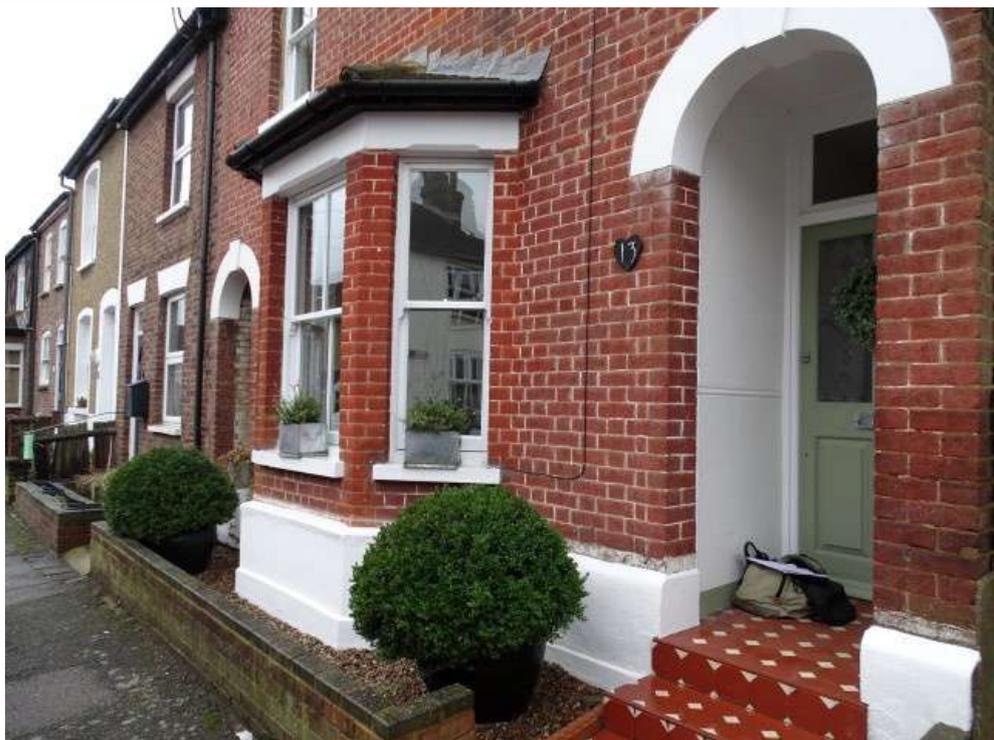
Front wall to right hand side of bay window wet

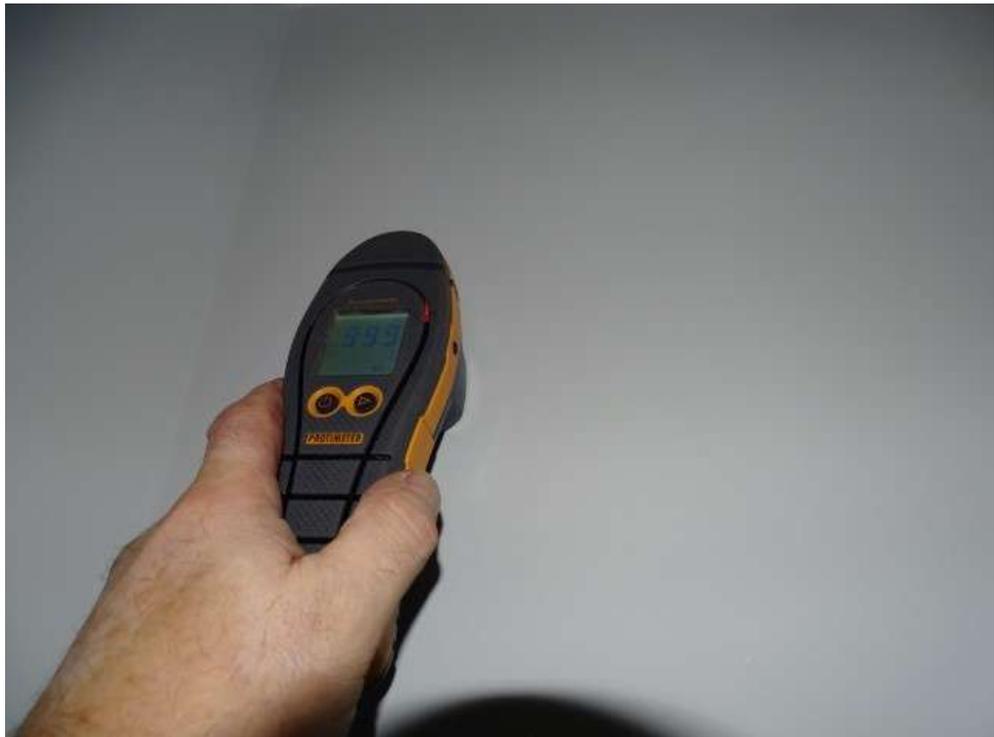
Dampness to front small bedroom to side of chimney

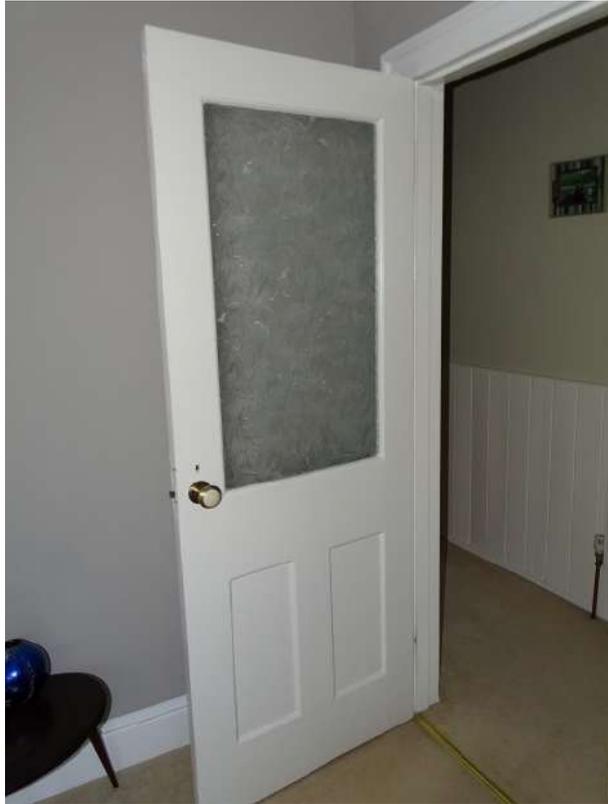
Fire Risk	Although smoke alarms are fitted at the property they have not been tested. You should ensure that there are sufficient devices fitted at the property and that they are all in good working order.
Safety Glass	The glass to the dining room and sitting room and bedroom two is not safety glass See also section 5.7.
Lead Pipes	A visual inspection was carried out, however pipes buried within walls or beneath the ground were not inspected.
Risk of Falls	. The lack of a suitable handrail on the staircase to the top section is a safety risk. Stairs Steepness: No Issue Noted Stairs Handrails: No Issue Noted Stairs Balustrades: No Issue Noted Window Cill heights: No Issue Noted Unprotected Balconies: No Issue Noted Trip Hazards: No Issue Noted
Unsafe Fittings	No issue noted by surveyor
Insect and Rodent Infestations	No issue noted by surveyor
Recent testing of services	There is no evidence of recent inspection of the electrical or heating systems, but certification may be available. See also 6.1 and 6.2.

Non safety glass to sitting room door

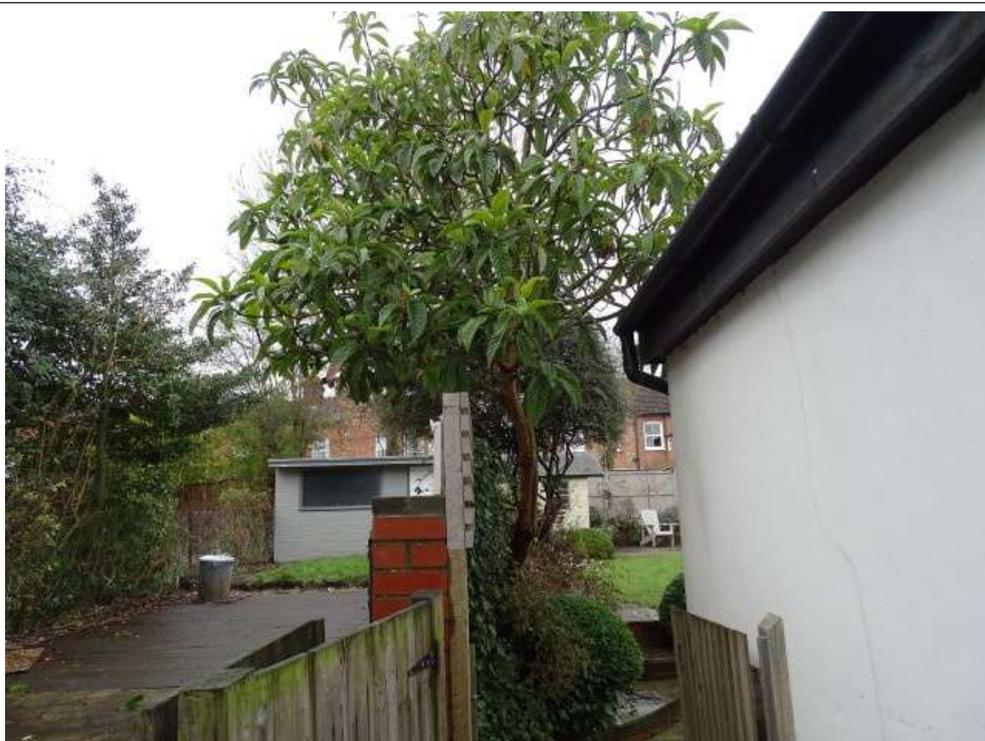
Condition	<p>There is no evidence of any damage from flooding.</p> <p>The gardens are both presented in a fair and highly maintained condition.</p> <p>The fencing is also presented in a fair condition.</p> <p>(There is no indication of the ownership of any of the boundary walls, fences or hedges, and in most cases this is not specified by the deeds or title documents. Often, responsibility for boundaries to one side or another has been assumed by subsequent owners. You should ask your conveyancer to advise on any indications of ownership included in the title documents.)</p>		
Action Required	<p>Normal Maintenance is Required. The sumac tree will need to be regularly maintained or removed.</p>

Sumac tree
