BUILDING SURVEY REPORT

SURVEY DATE 19 Dec 2017

REF Alan Rance

The format of this MiBuilding Survey Report is consistent with the guidance note requirements for a Survey Level 3 as defined by RICS Surveys of Residential Property 3rd edition May 2016

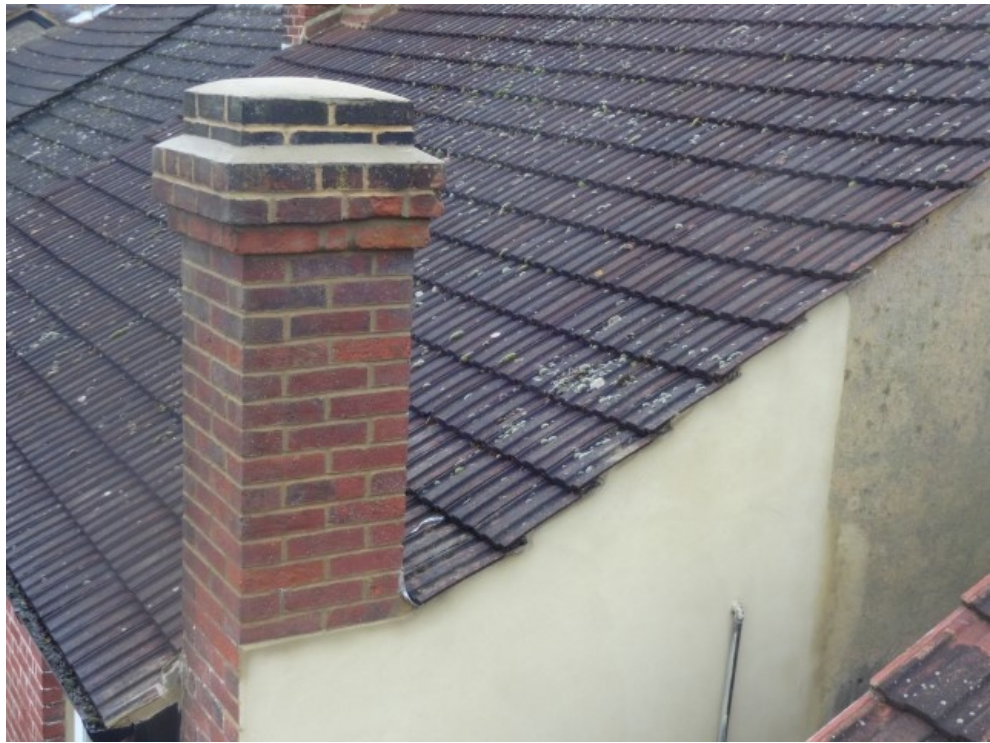
Front bedroom chimney capped stack Change position

Nature of inspection and Limitations	<p>The chimney was examined from ground level with the aid of binoculars for possible defects including undue movement, distortion, chemical or weather related damage, brickwork, render and pointing damage and other evidence of failure.</p> <p>Due to limited viewing angles it is not possible to see all faces of the chimney stack from ground level, and it is assumed that the condition of those faces not visible is similar to that of the visible faces.</p>		
Condition	<p>All flashing's should be replaced in lead ,There is a crack between the two chimneys between the properties this should be sealed to prevent water getting down the back. brickwork and pointing seen were in a fair condition.</p>		
Action Required	<p>The pots to the main stack do not have a rain cowl correctly fitted to allow flue gases to escape but prevent vertical rain entering the flue line both flues should be ventilated at the base of the flues to clear damp in the flue .</p> <p>Bedroom 3 fireplace has been capped over. The tiled flashing has cracked and is allowing water to penetrate. The bottom rows of tiles will need to be removed and the flashing replaced in lead and sarking felt checked and replaced where necessary and the back gutter</p>

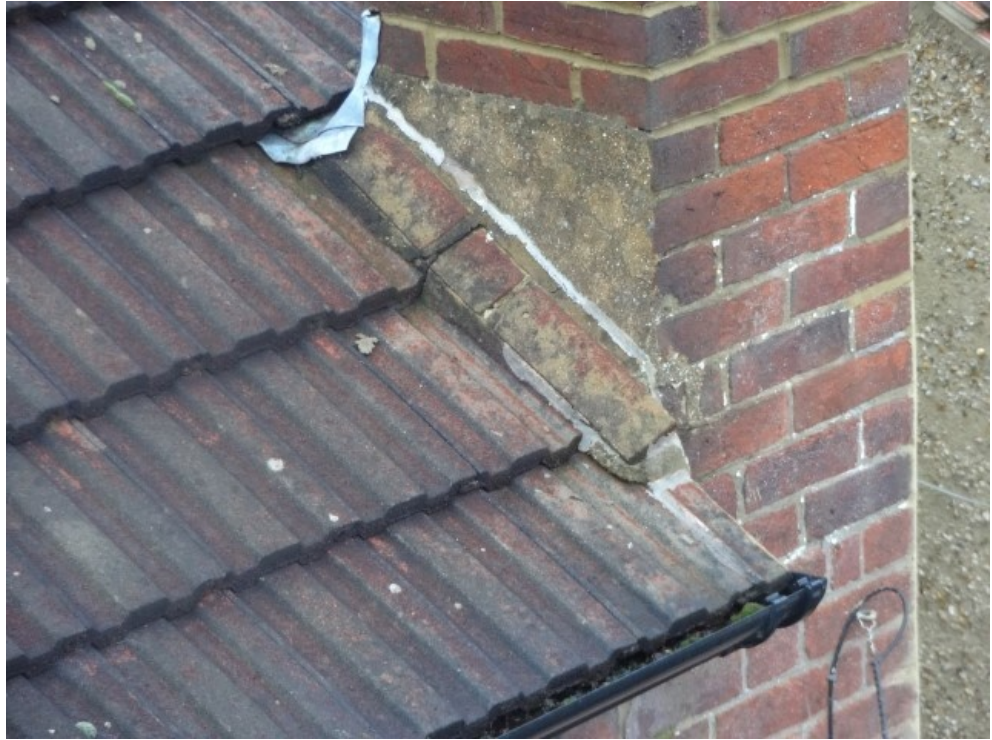
Tiled flashing to chimney stack

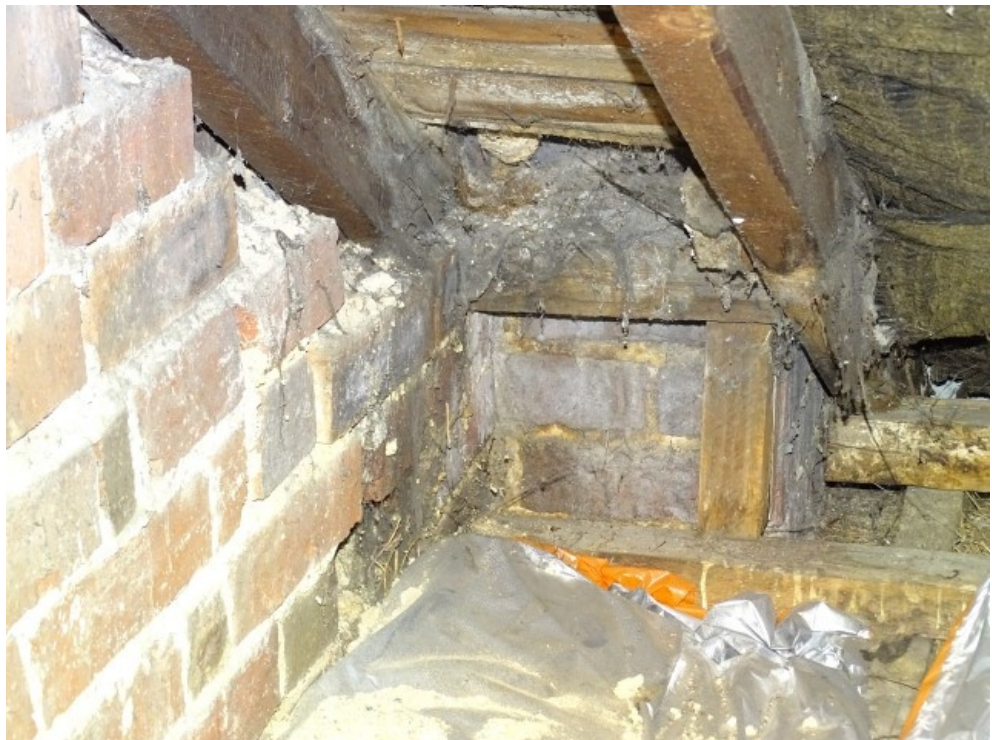
Chimney stack from small front bedroom showing dropped sarking felt

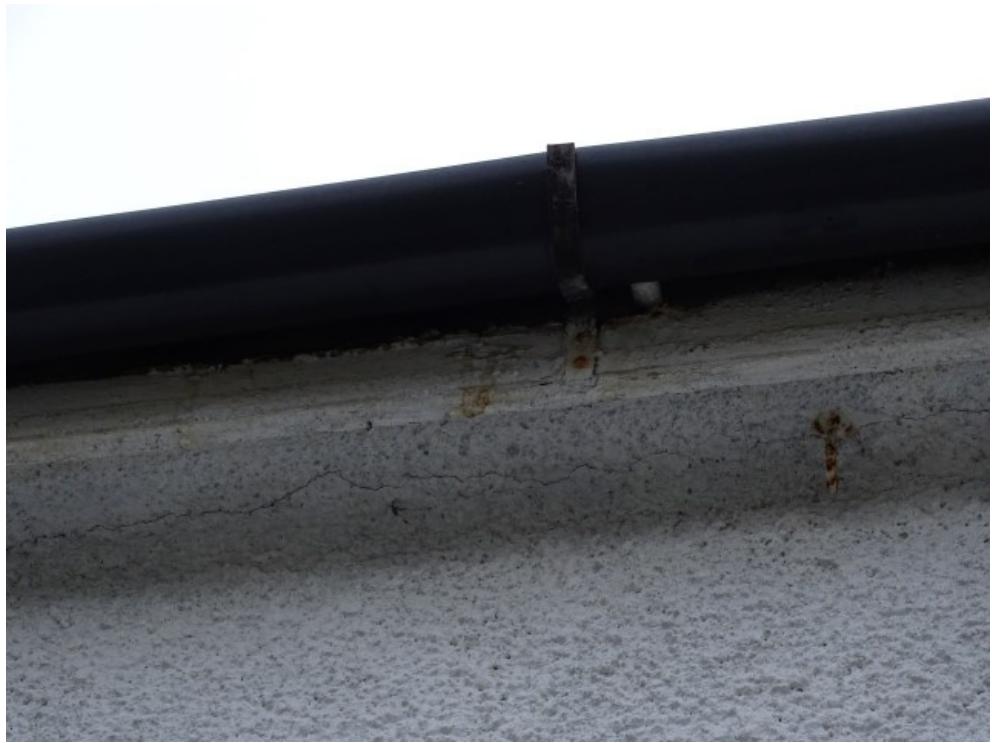
Condition	<p>The gutters are currently in fair condition and alignment. There were no significant leaks noted but all gutters require examining periodically and clearing of moss, leaves and silt which will inevitably accumulate.</p> <p>All gulleys were clear at the time of the survey with no evidence of any flooding or other drainage problems. However all gulleys require regular clearing of any debris that will accumulate over relatively short periods of time.</p> <p>The soil stack and associated plumbing is in a fair condition with no leakages noted.</p>		
Action Required	<p>Gutters and downpipes should be cleaned and inspected regularly to ensure that they are free from blockages and leaks. The rear gutters to the main house are fitted with old metal brackets these should be replaced. The gutters to the rear right hand side look very wavy and should be realigned with additional brackets and cleaned out.</p>

Rear gutter to main house

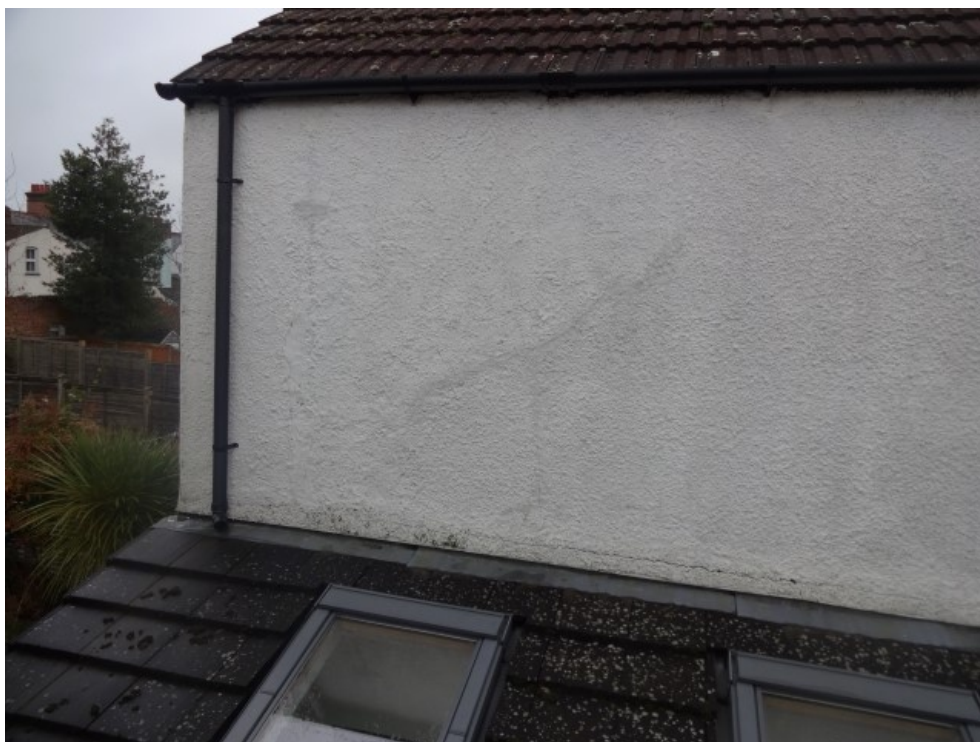
<p>General</p>	<p>The most serious issues present at the time of the survey is the dampness and cracking within the external side walls. There are a number of medium level issues that require attention together with some minor observations made in the following report sections.</p> <p>It should be noted that in any property of this age there will be general unevenness of the surfaces and structures of walls, floors, ceilings, doors, windows and other elements. These have occurred due to settlement of the structure and general usage over an extended period. It is not possible to highlight each individual example of such distortions and only those felt to be of an unusual nature have been highlighted.</p>
<p>Main Issues</p>	<p>-Issue 1 Dampness was found in the rear and right hand gable wall of the kitchen. In the dining room chimney breast at high level. To the covered alley way at low level up to the sitting room chimney breast and in the sitting room from the bay window to the hall.</p> <p>- Issue 2 The render is cracked in the side wall of the kitchen dining area and has been repaired but is cracking again internally it is lined with plasterboard so is not seen inside. The side wall of bedroom 4 is cracked in the render and allowing water to penetrate the wall</p>

Cracked render to bedroom 4

<p>Action Required</p>	<p>The rear gable wall to the right hand side needs repointing. This complete wall has been covered with bitumen and paint and rendered over in area's to prevent rain penetration previously as the kitchen is wet above the worktop areas this will need evaluating by a specialist and to see if there is a guarantee on the damp proofing that was done as the whole kitchen may need to be taken out. The crack in the render may need to be reinforced by the installation of Heli fix style reinforcing product to the side wall and above bedroom one window. This you will need to get a specialist report on. Repoint small area to side of bedroom 3 brickwork.</p>
<p>Additional Information</p>	<p>I can send you details of specialist company's that will give reports on products for repairing the cracks</p>
	<div data-bbox="416 633 1406 1370" data-label="Image"> </div> <p data-bbox="683 1391 1134 1417">Crack above main bedroom window head</p>

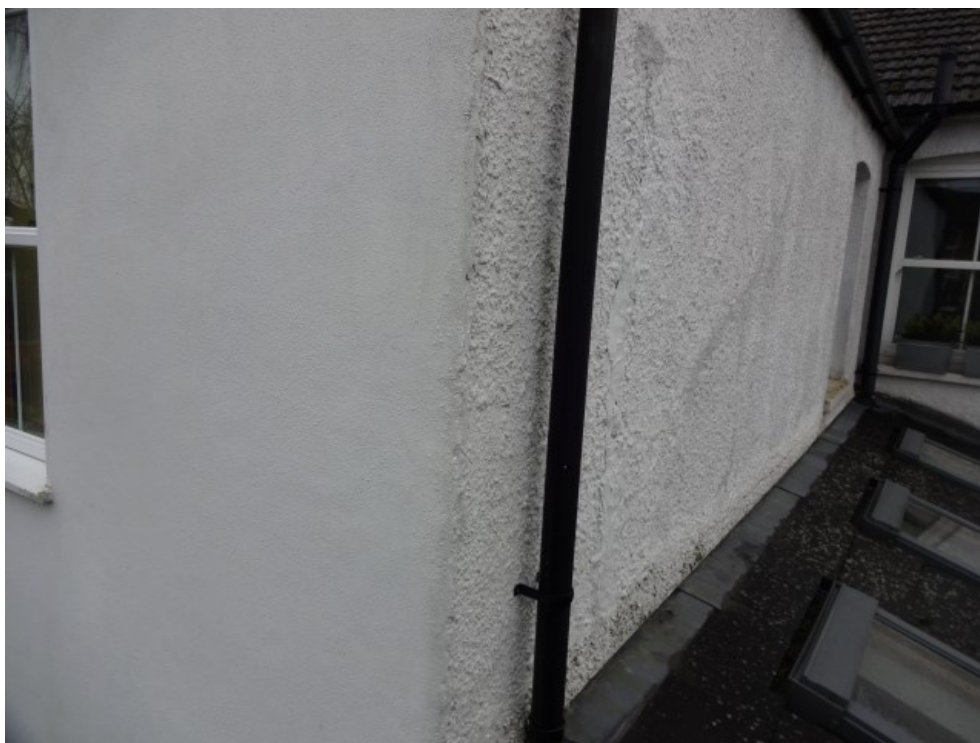
Cracked render to bedroom 412DUPLICATE Name - Change position

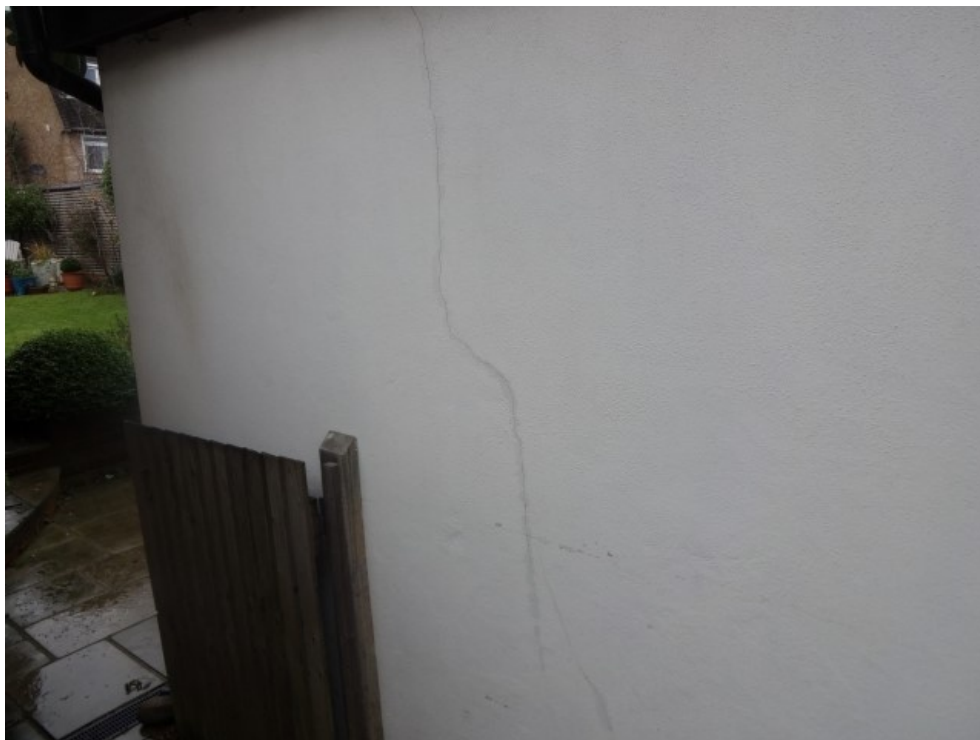
Cracked render to left hand side of kitchen

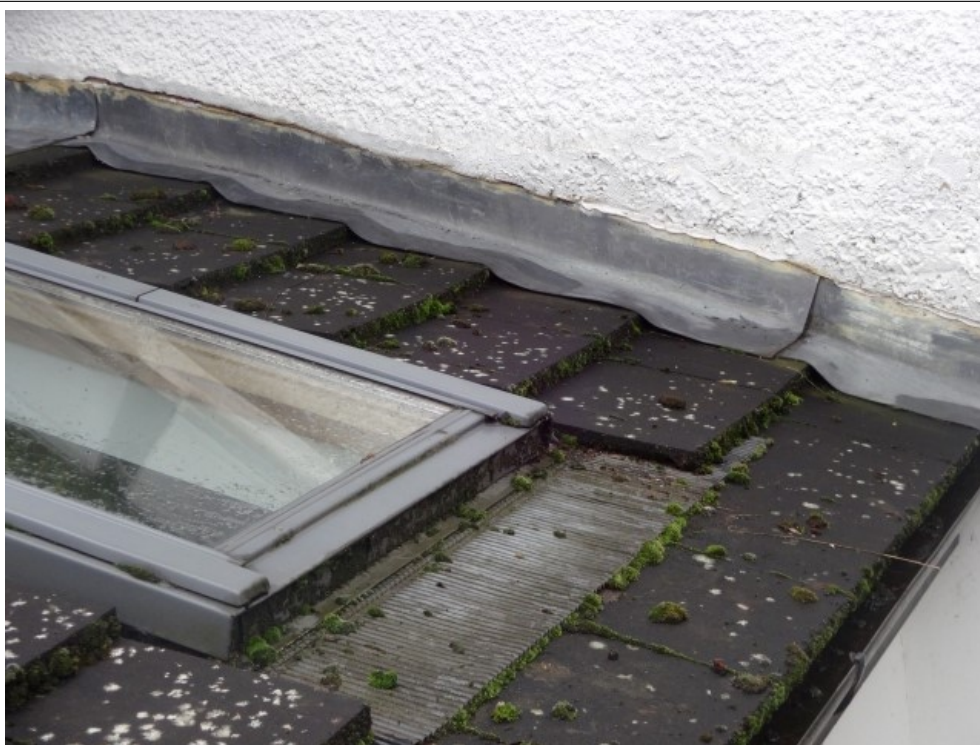
Render cracking above lead flashing onto roof of dining area

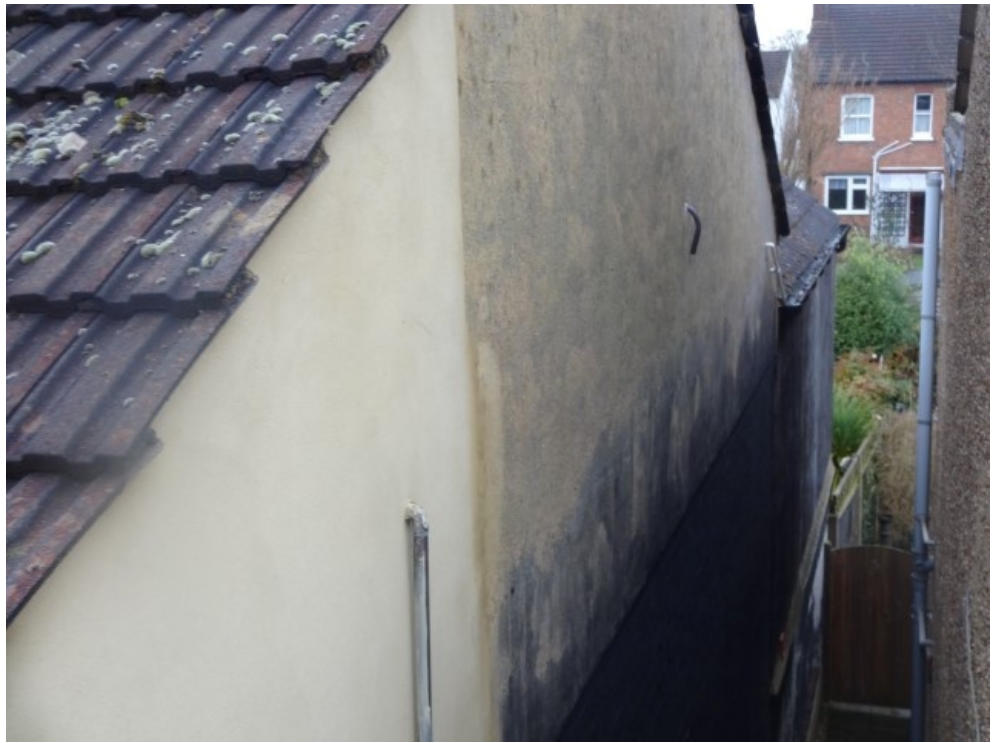
Right hand gable end rendered down to first floor

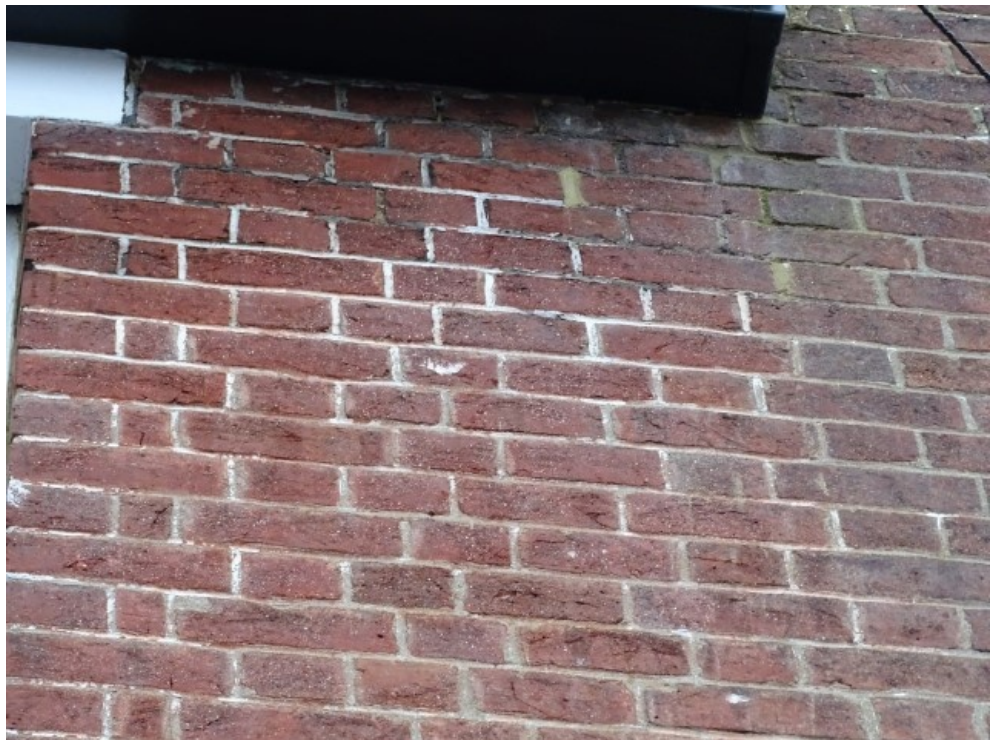
Re-pointing required to right hand side of bedroom 3 window

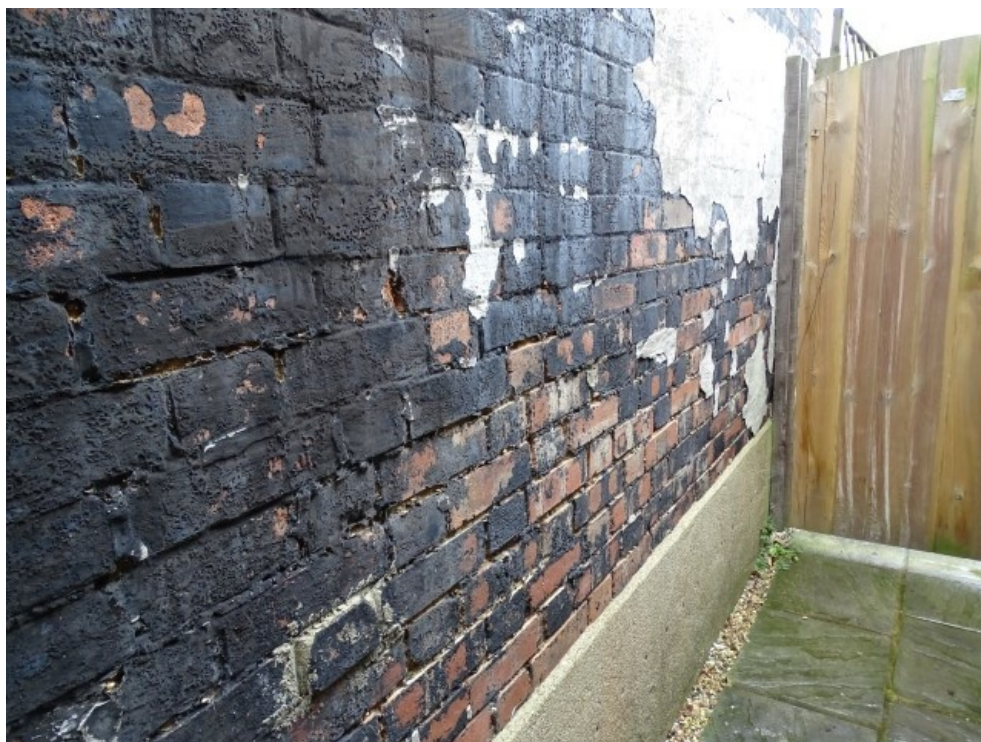
Rear gable wall right hand side rear of kitchen

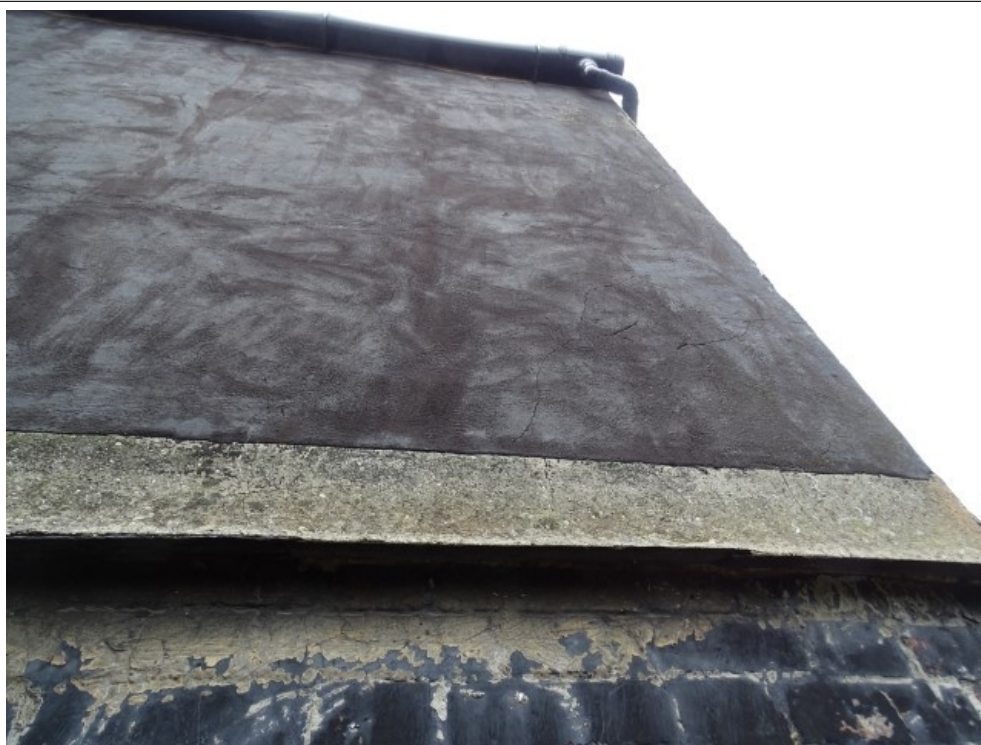
First floor rear gable wall cracks in render

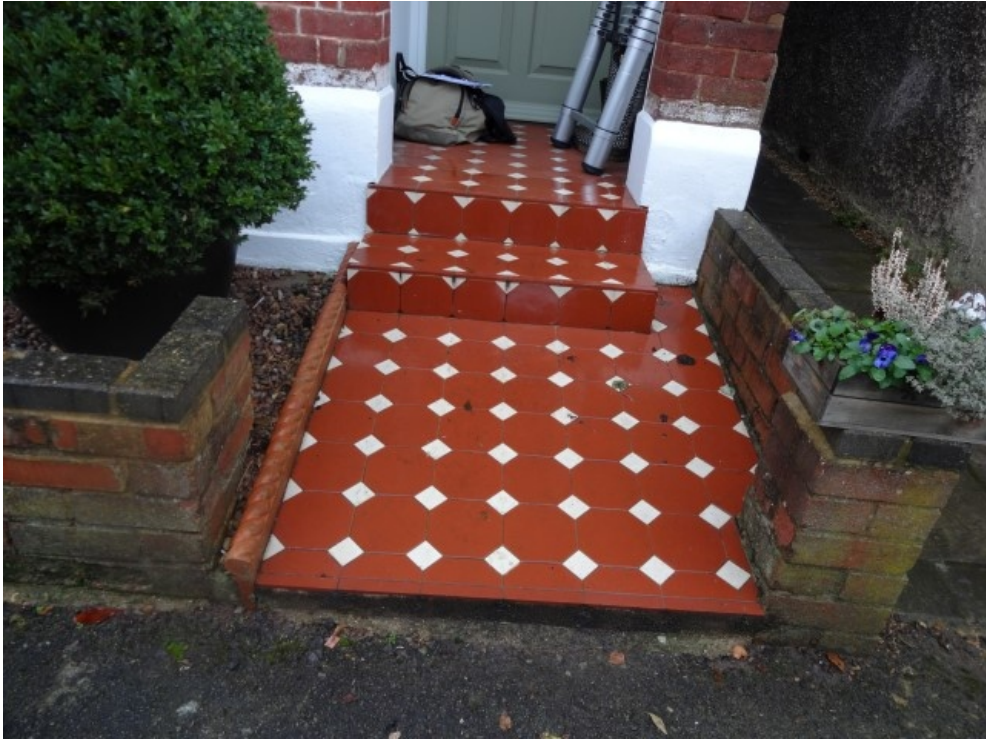
<p style="text-align: center;">Front step sloping and slippery in the wet</p>

<h2 style="background-color: #0056b3; color: white; padding: 5px;">4.7 Conservatories and Porches</h2>	<p style="text-align: center;">Condition rating</p>	1
<p>Construction & Type</p>	<p>The porch to the front is set within the property and is open to the elements. The floor is tiled and runs to the front of the property.</p> <p>There is no conservatory to this property.</p>		
<p>Nature of inspection and Limitations</p>	<p>The porch structure was examined for indications of leaking, bowing, leaning, cracking and failure or damage of the floor, walls and roof and other defects.</p>		
<p>Condition</p>	<p>No significant defects are noted to the structure.</p>		
<p>Action Required</p>	<p>A none slip surface should be fitted to the external sloping tiles.</p>

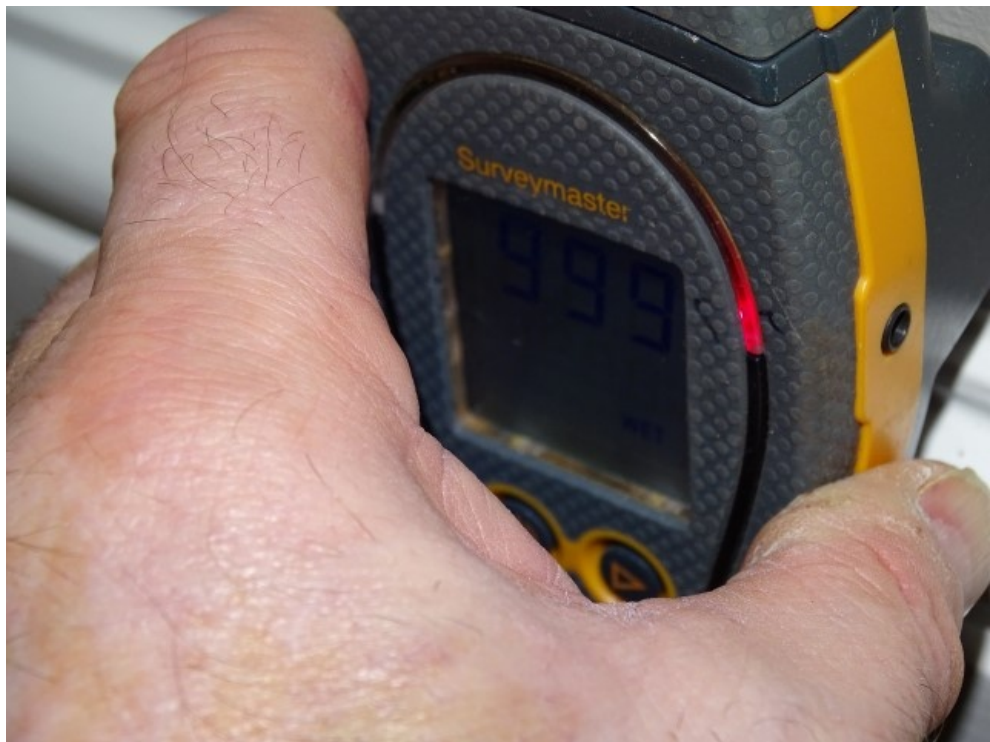
5.3 Walls	Condition rating	3
Construction & Type	<p>The internal walls are of both solid and timber stud construction.</p> <p>The inside faces of some of the external walls have been dry-lined.</p>		
Nature of inspection and Limitations	<p>Internal walls were examined for indications of bowing, leaning, cracking and undue surface failure/damage. Moisture meter readings were taken at regular intervals where access and wall construction/location permitted.</p>		
Condition	<p>All internal walls and ceilings have been maintained and all surfaces are presented in a fair decorative order. Some general unevenness was noted. This is due to normal disturbance of the surface by decorations, minor repairs and fittings having been attached in the past.</p> <p>Dampness was found in the rear and right hand gable wall of the kitchen. In the dining room chimney breast at high level. To the covered alley way at low level up to the sitting room chimney breast.and in the sitting room from the bay window to the hall.</p> <p>Some of the internal walls are dry-lined or of timber stud construction. This means that special fixings will be required where heavy objects are to be hung onto or attached to the walls as the plasterboard facing of the walls is not sufficiently strong to carry heavy weights. It will also be the case that picture hooks and other nailed-in fixings will only have a light hold within the wall facing.</p> <p>No significant defects were noted during my inspection and the internal walls were found to be structurally sound.</p>

Dampness to front wall of sitting room

Action Required	<p>Wall Removal: As part of the legal process, your legal adviser should contact building control at the local council and obtain any records of any notifiable works completed.</p> <p>Normal maintenance is required, including filling and redecorating cracks as necessary.</p> <p>Dampness was found in the rear and right hand gable wall of the kitchen. In the dining room chimney breast at high level. To the covered alley way at low level up to the sitting room chimney breast.and in the sitting room from the bay window to the hall.</p>		
Additional Information	<p>A specialist should be contacted to give a report and quotation for treating the walls.</p>

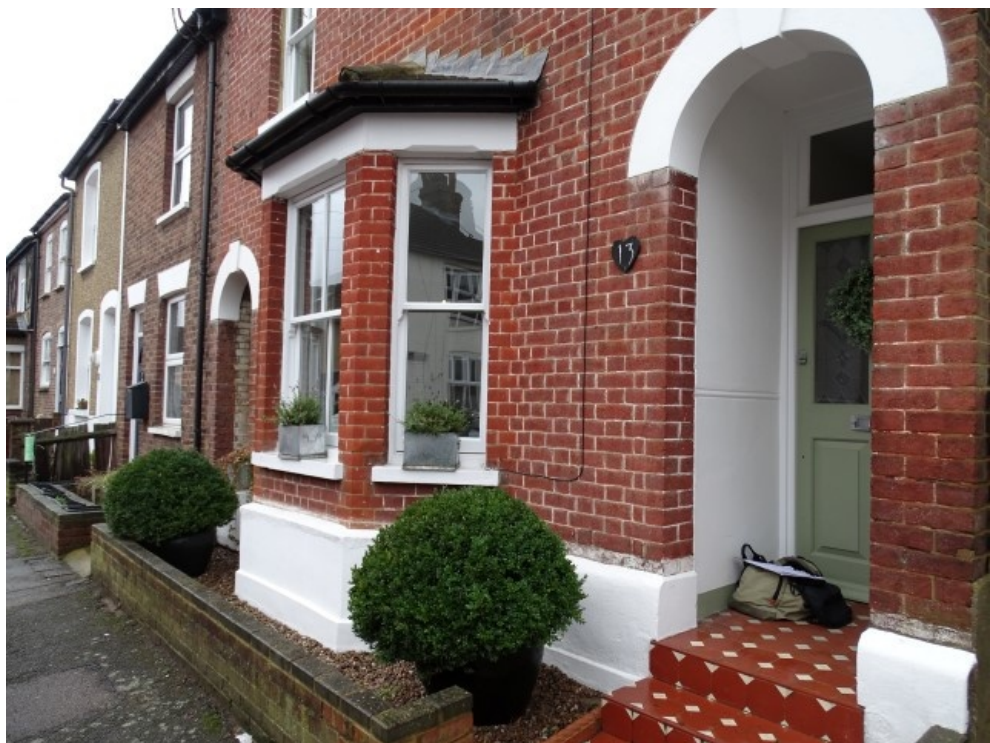
Front wall to right hand side of bay window wet

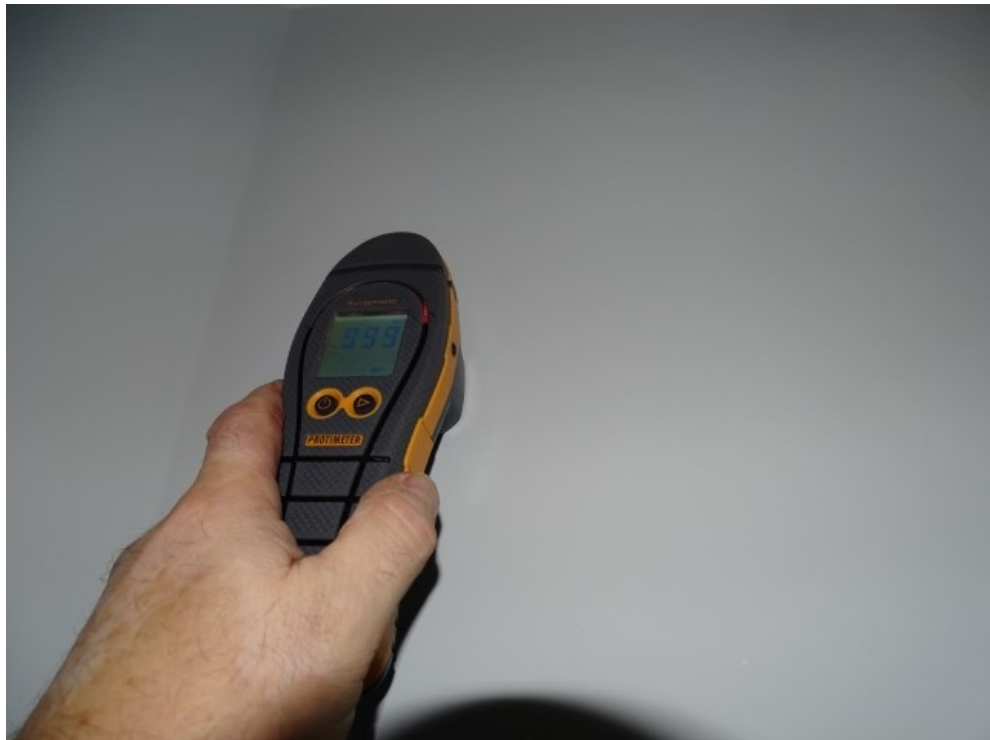
Dampness to front small bedroom to side of chimney

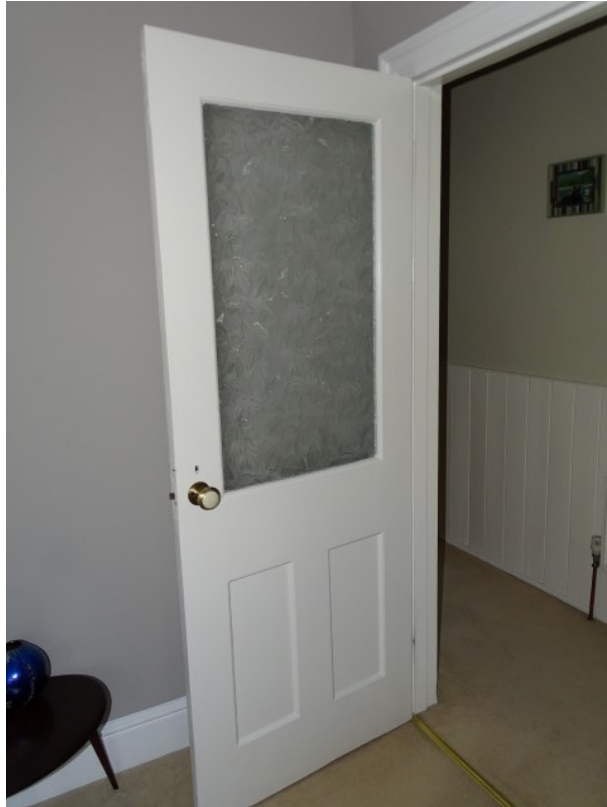
Fire Risk	Although smoke alarms are fitted at the property they have not been tested. You should ensure that there are sufficient devices fitted at the property and that they are all in good working order.
Safety Glass	The glass to the dining room and sitting room and bedroom two is not safety glass See also section 5.7.
Lead Pipes	A visual inspection was carried out, however pipes buried within walls or beneath the ground were not inspected.
Risk of Falls	. The lack of a suitable handrail on the staircase to the top section is a safety risk. Stairs Steepness: No Issue Noted Stairs Handrails: No Issue Noted Stairs Balustrades: No Issue Noted Window Cill heights: No Issue Noted Unprotected Balconies: No Issue Noted Trip Hazards: No Issue Noted
Unsafe Fittings	No issue noted by surveyor
Insect and Rodent Infestations	No issue noted by surveyor
Recent testing of services	There is no evidence of recent inspection of the electrical or heating systems, but certification may be available. See also 6.1 and 6.2.

Non safety glass to sitting room door

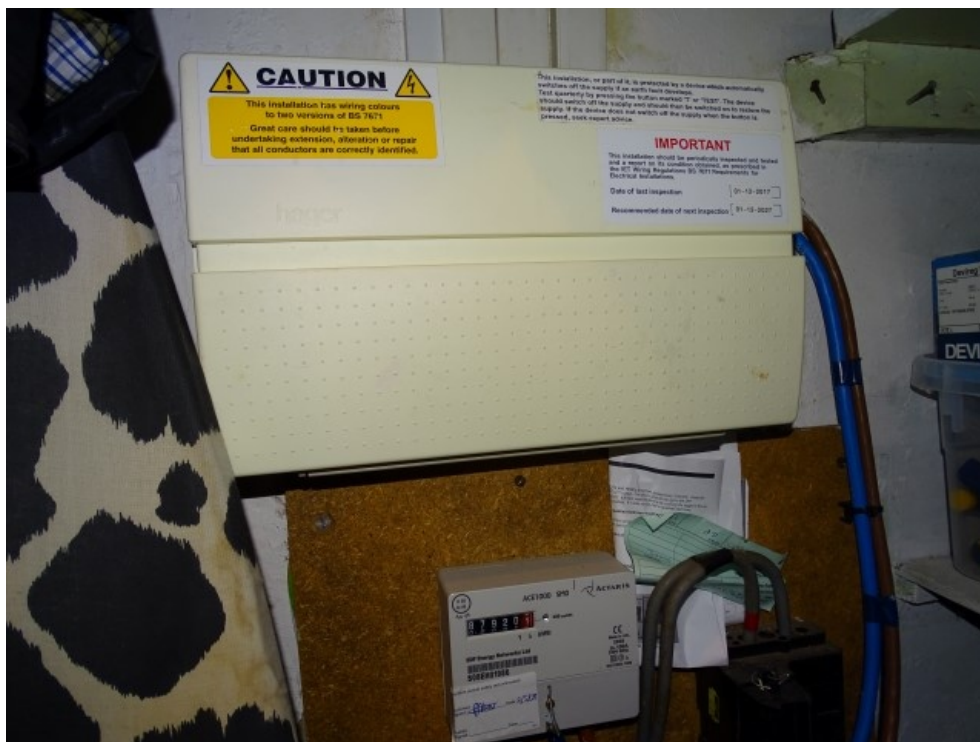
Condition	<p>In general the electrical circuits seen are in a fair condition. PVC cabling was observed at the property and the socket face plates and switch plates are of a suitable modern quality. However to some rooms there are an insufficient number of sockets for modern living standards, this means a level of new circuitry or rewiring may be required. There are also some specific observations listed below which require attention.</p> <p>-The electrics were tested on 1st December a copy of the report should be asked for and read.</p>		
Action Required	<p>Some services will be obscured by furniture and other objects at the time of the survey. Upon occupation it is strongly advisable to visually check all socket outlets and switch points for any broken housings or loose fascias. Any damage seen should be repaired accordingly.</p> <p>The NICEIC recommends that electrical installations are subjected to an Electrical Installation Condition Report (EICR) by a suitably qualified engineer at least every 10 years. They further recommend that a PIR be carried</p>

Electric meter and consumer unit

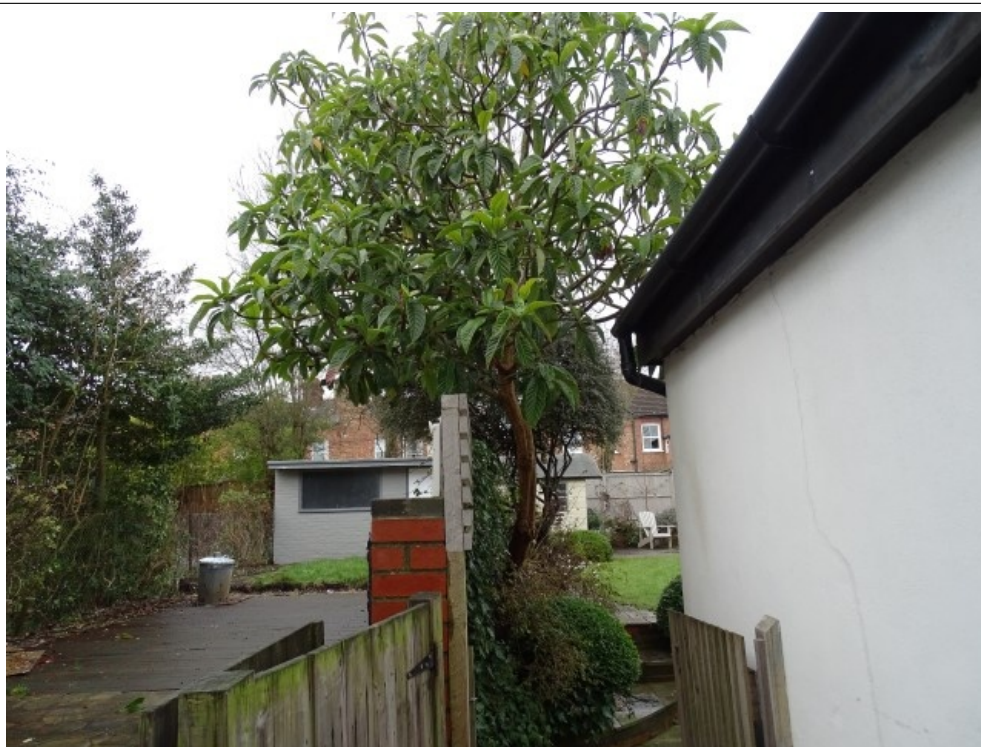
Condition	<p>There is no evidence of any damage from flooding.</p> <p>The gardens are both presented in a fair and highly maintained condition.</p> <p>The fencing is also presented in a fair condition.</p> <p>(There is no indication of the ownership of any of the boundary walls, fences or hedges, and in most cases this is not specified by the deeds or title documents. Often, responsibility for boundaries to one side or another has been assumed by subsequent owners. You should ask your conveyancer to advise on any indications of ownership included in the title documents.)</p>		
Action Required	<p>Normal Maintenance is Required. The sumac tree will need to be regularly maintained or removed.</p>

Sumac tree
